DEPARTMENT OF TRANSPORTATION

Contract #: 04-0120F4Cty: SF/ALA Rte: 80 PM: 13.2/13.9File #: 69.28**WELDING INSPECTION REPORT****Resident Engineer:**Pursell, Gary**Address:** 333 Burma Road**City:** Oakland, CA 94607**Report No:** WIR-009529**Date Inspected:** 08-Oct-2009**Project Name:** SAS Superstructure**OSM Arrival Time:** 1900**Prime Contractor:** American Bridge/Fluor Enterprises, a JV**OSM Departure Time:** 700**Contractor:** Zhenhua Port Machinery Company, Ltd (ZPMC), Changxing Island **Location:** Shanghai, China**CWI Name:** Wang Chuan Ging , Tu Jun**CWI Present:** Yes No**Inspected CWI report:** Yes No N/A**Rod Oven in Use:** Yes No N/A**Electrode to specification:** Yes No N/A**Weld Procedures Followed:** Yes No N/A**Qualified Welders:** Yes No N/A**Verified Joint Fit-up:** Yes No N/A**Approved Drawings:** Yes No N/A**Approved WPS:** Yes No N/A**Delayed / Cancelled:** Yes No N/A**Bridge No:** 34-0006**Component:** Tower/OBG**Summary of Items Observed:**

WELDING INSPECTION REPORT

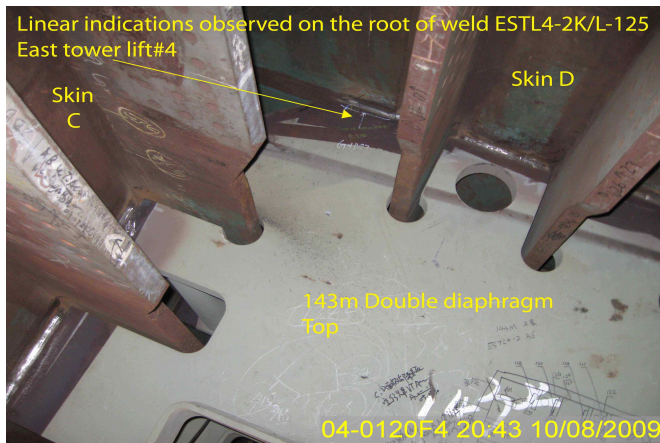
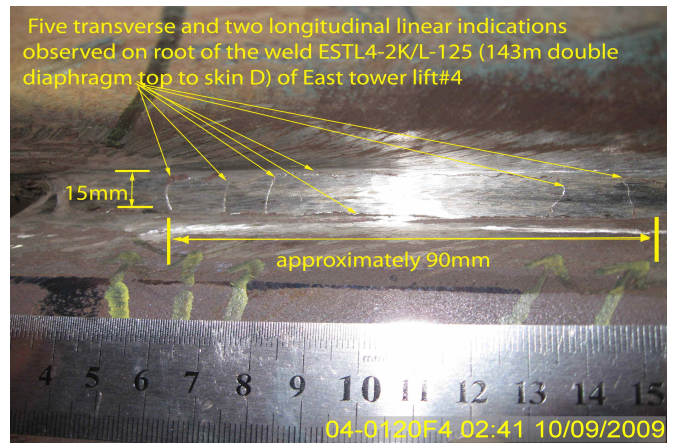
During random visual inspection of East tower lift #4, this Caltrans Quality Assurance (QA) Inspector observed five transverse and two longitudinal linear indications in the root of the 143m double diaphragm top to the skin 'D' weld ESTL4-2K/L-125. The linear indications were shown to ZPMC and ABF QC Inspectors. See the photos

below for additional information.
